**TELEDYNE CONTINENTAL<sup>®</sup> AIRCRAFT ENGINE**  
**MANDATORY SERVICE BULLETIN**

**Category 1**  
**MSB07-4**

**SUBJECT:** KELLY AEROSPACE POWER SYSTEM'S TURBOCHARGER REPLACEMENT

## TURBOCHARGER INSPECTION AND REPLACEMENT

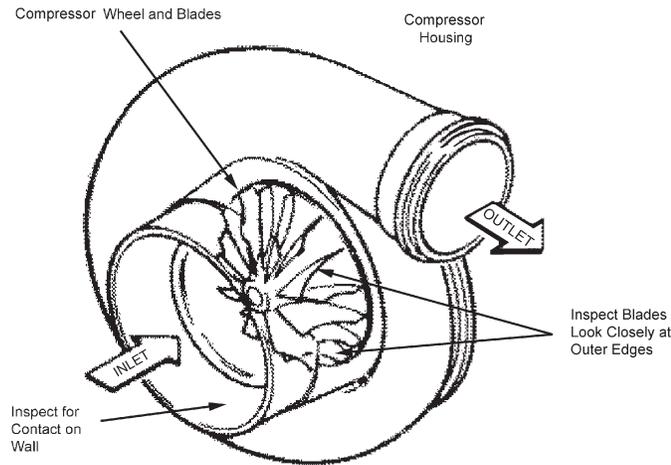
**Figure 2 - Turbocharger Inspection Points**

3. Visually inspect each turbocharger through the compressor inlet for any signs of contact. Look for witness marks from the impeller wheel, giving careful attention to the outer edges of the wheel blades and the inner wall of the compressor housing. Contact marks on the housing from the wheel will appear as a burnishing on the inner wall. Grooves or gouges of any sort are cause for turbocharger replacement. Utilize supplemental lighting if needed to facilitate visual inspection. Refer to Figure 2, page 3.

4. If any anomalies are noted during the visual inspection, replace the turbocharger. If nothing appears in the visual inspection, the turbocharger is suitable for further use. This will allow the aircraft to be relocated to a qualified facility for turbocharger replacement.
